C-5149-14-H

Property Condition Report-Terracon Project Number 92088503
Memorial Middle School, Pharr-San Juan-Alamo ISD, Pharr, Texas
Photos, Date Taken: January 7, 2008

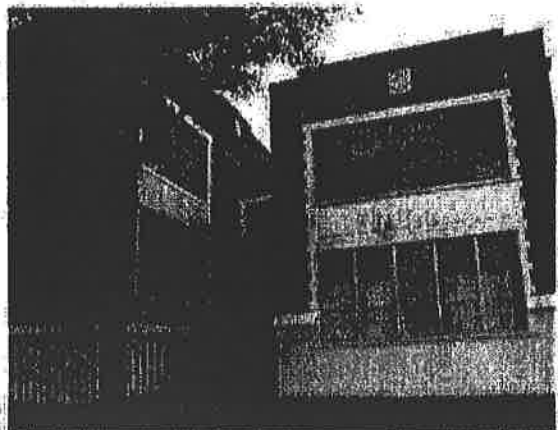
Photo #6 View of added west wing at juncture with original Main Building. Note broken and barricaded windows.

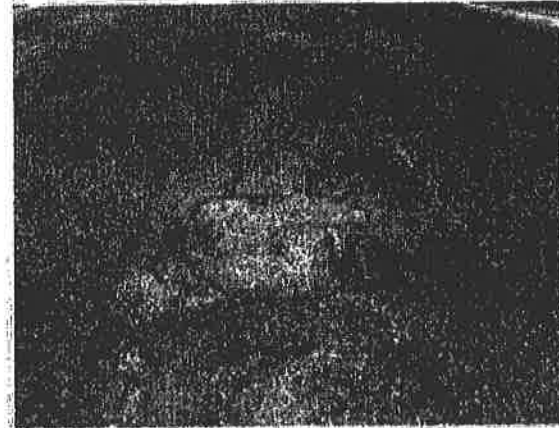
Photo #30 Typical deteriorated asphalt pavement.

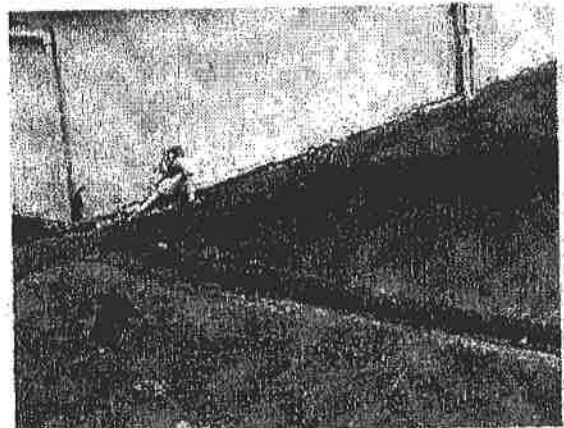
Photo #32 Elevated walkway failure at entrance to Main Building auditorium.

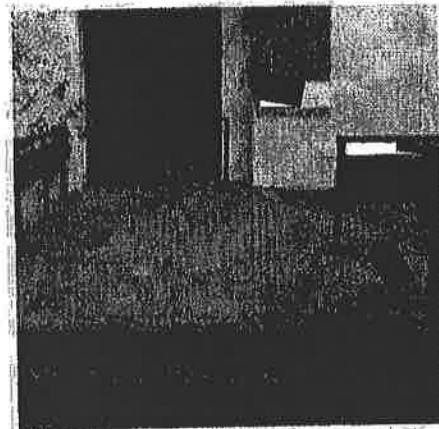
Photo #34 Elevated walkway failure shown in Photo #33. Note barricaded door.

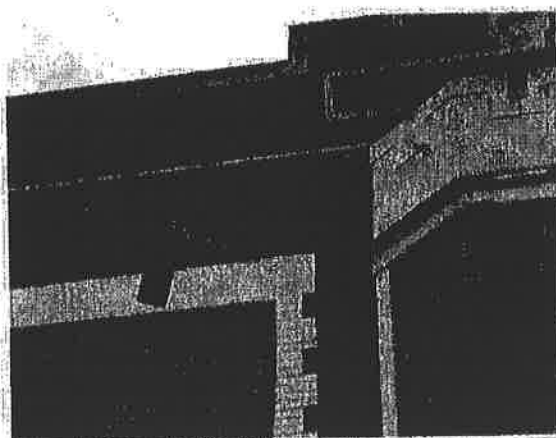
Photo #35 Masonry stair-step diagonal cracking on Main Building. Note deteriorated wood trim.

There are no significant signs of structural distress on any of the buildings' foundations. There are some noted perimeter wall cracks on the Main Building and the old band hall wing of the Stambaugh Building. These cracks are most likely caused by minor differential settlement of the foundations and can be readily repaired by underpinning the perimeter foundation beams with cast-in-place concrete drilled piers.

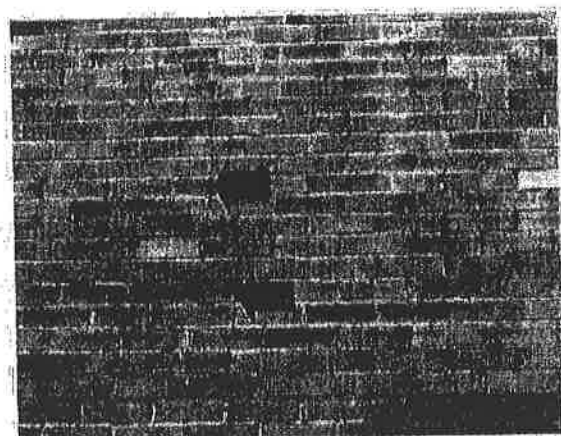
Photo #36 Masonry vertical cracking on Stambaugh Building, old band hall wing.

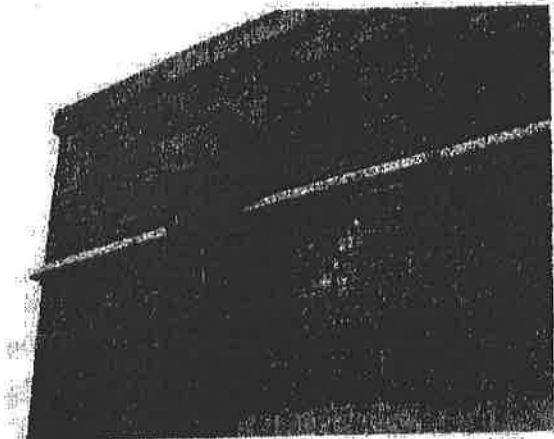
Photo #38 Typical aged, deteriorated, and patched mortar on Main Building.

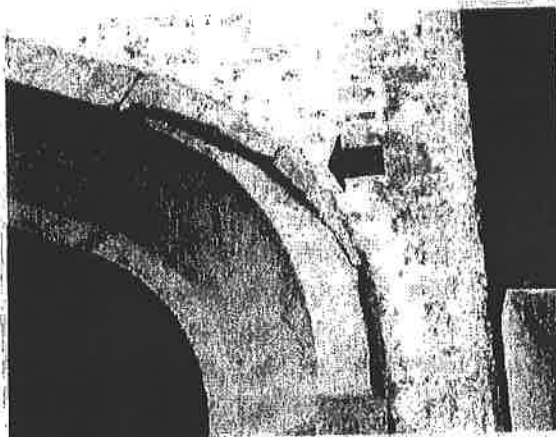
Photo #39 Typical deteriorated pre-cast architectural concrete on Main Building. Note exposed and corroded reinforcing steel.

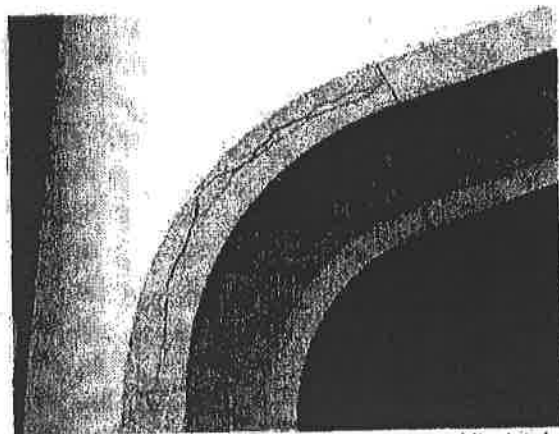
Photo #40 Typical deteriorated pre-cast architectural concrete on Main Building.

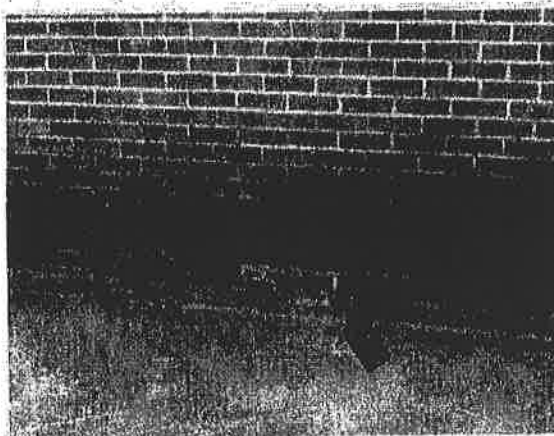
Photo #43 Typical masonry staining. Note old band hall crawl space vent with no pest screen.

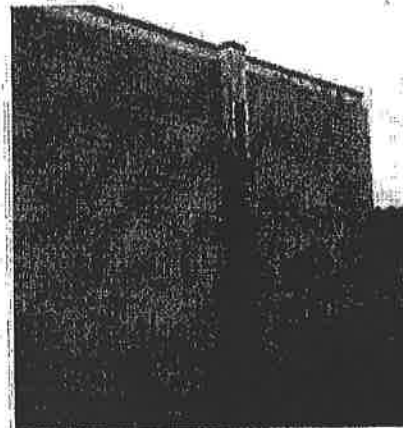
Photo #44 Typical masonry staining from downspout on Textbook Department building.

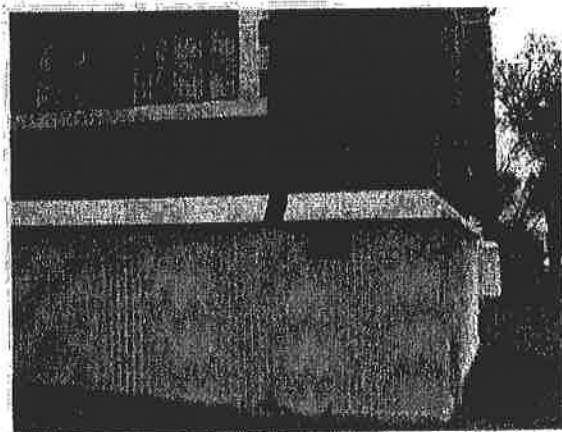
Photo #45 Typical damaged downspout on Main Building.

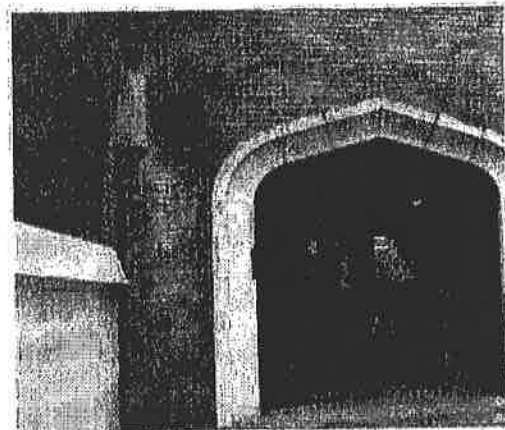
Photo #46 Typical damaged downspout on Main Building. Note moisture staining.

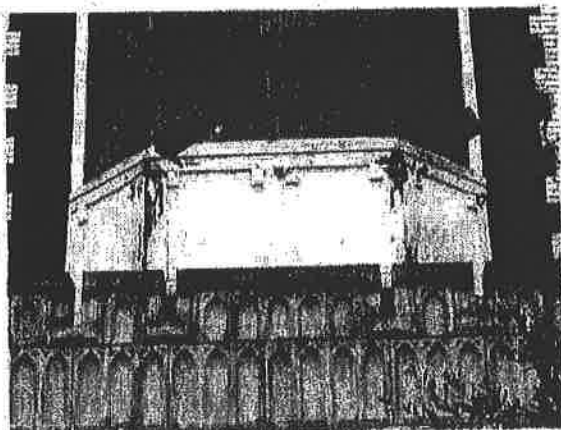
Photo #47 Typical deteriorated wood trim.

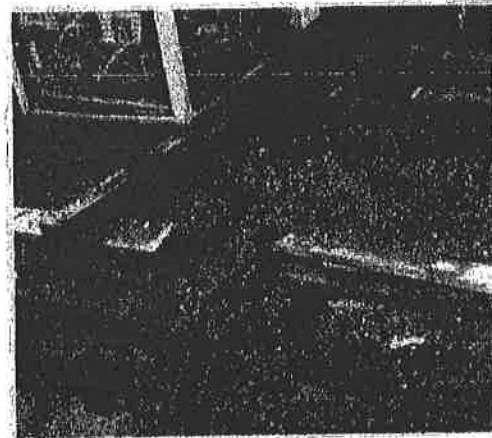
Photo #50 Typical damaged HVAC equipment supports. Note exposed and deteriorated bitumen roofing.

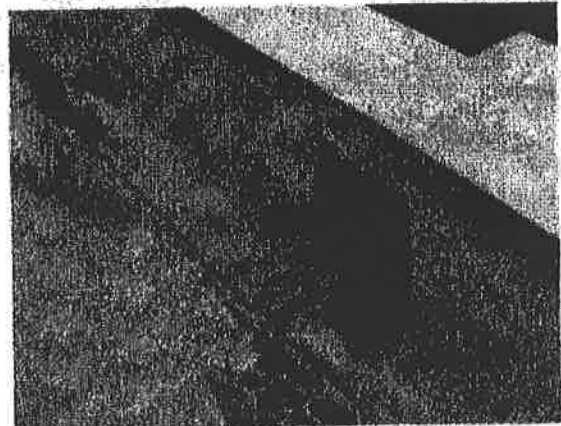
Photo #52 Flashing at scupper on Textbook Department building. Note separation of plies.

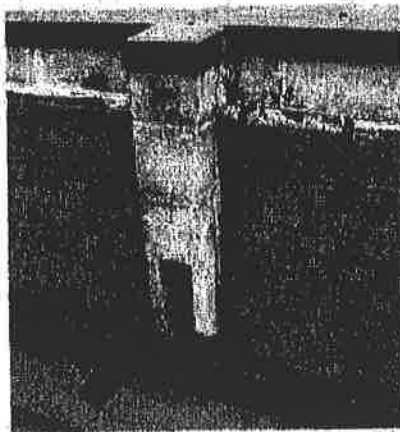
Photo #53 Deteriorated parapet wall and downspout on Textbook Department building upper roof. Note missing splash block.

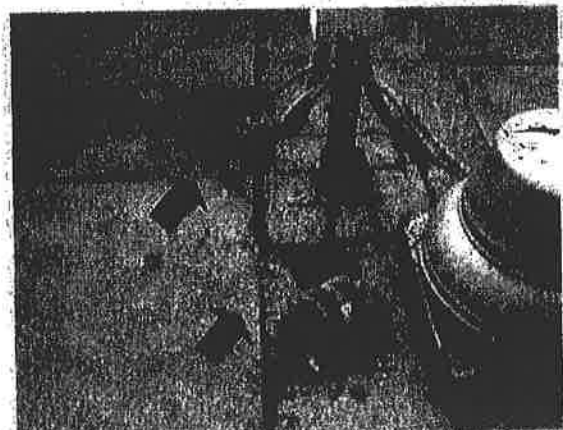
Photo #54 Typical debris on roof and unsupported piping.

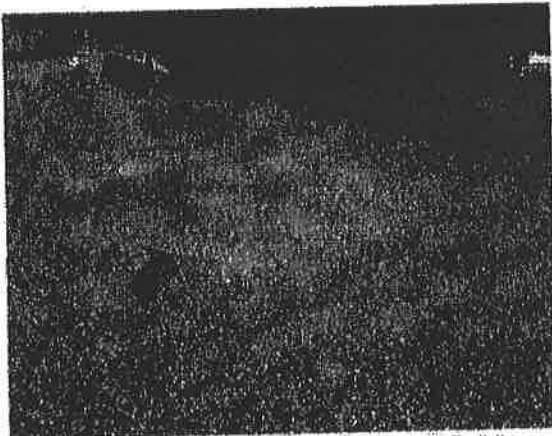
Photo #55 Area of ponding on Stambaugh Building roof. Note tree on edge of roof requiring trimming.

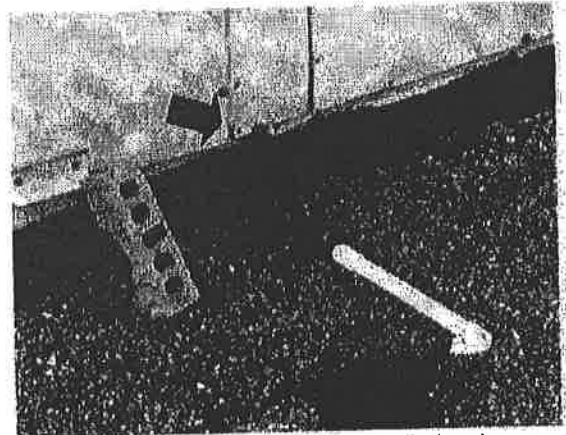
Photo #56 Broken condensate drain discharging condensate onto roof.

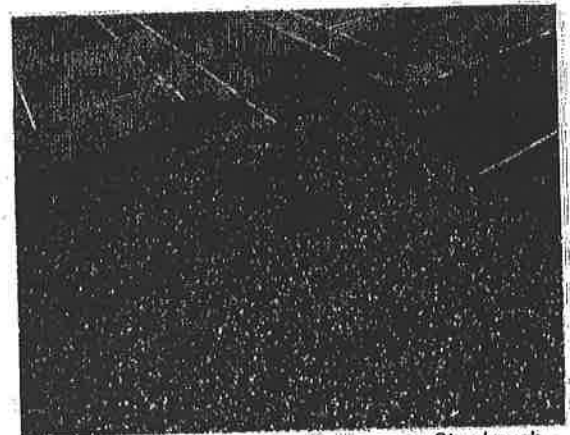
Photo #58 Missing roof drain screen on Stambaugh Building.

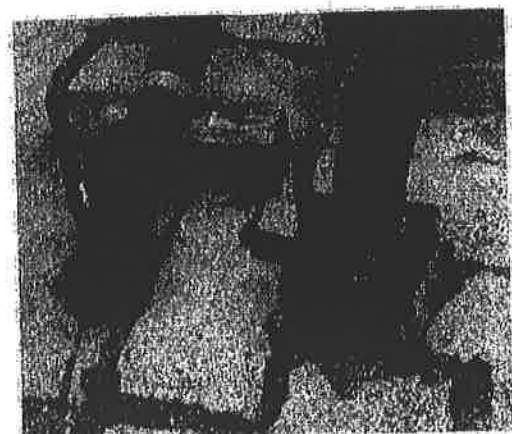
Photo #60 Typical improperly constructed pitch pan.

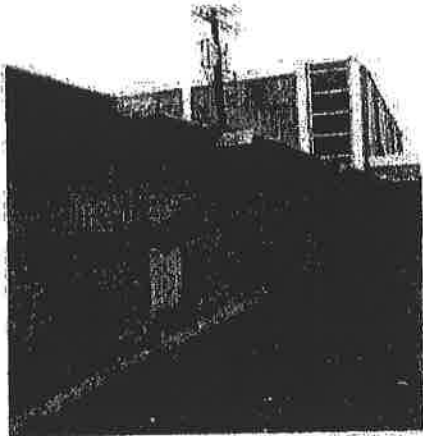
Photo #61 Deteriorated fascia and roof at Field Locker Room building.

Surface corrosion of the steel framing and or metal roof decking is existent on either side of the original corridor connection the Main Building to the auditorium. There are large areas, two to three square feet in size, of deteriorated metal roof decking of the Field Locker Room Building.

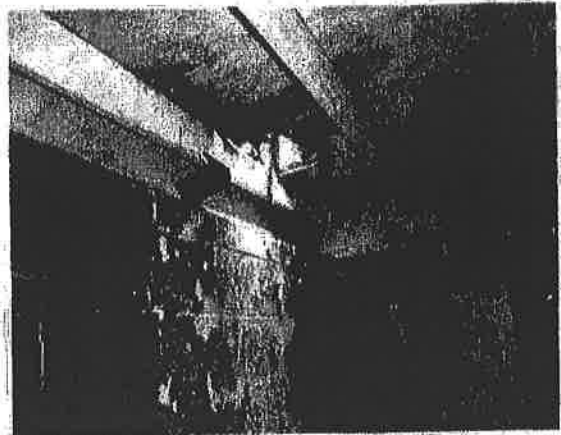
Photo #62 Deteriorated roof of Field Locker Room building.

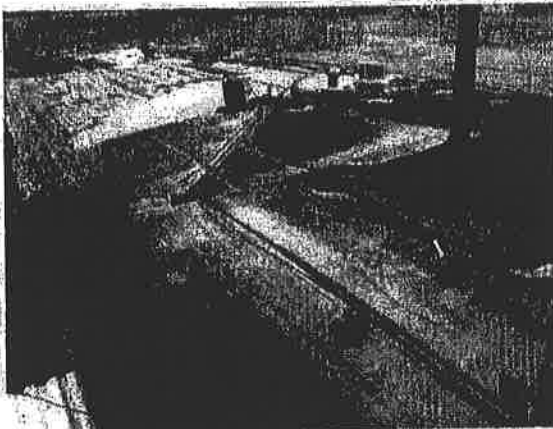
Photo #63 View of deteriorated roof at Field Locker Room building.

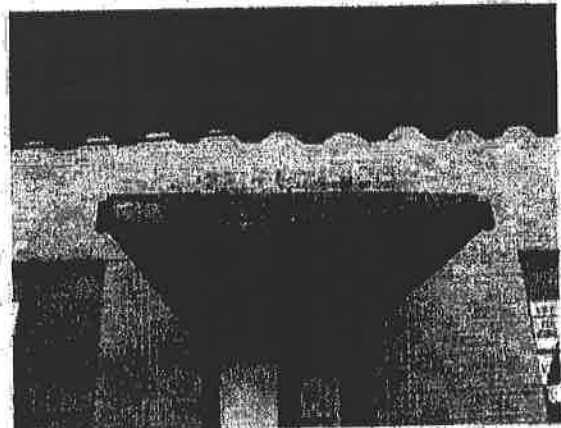
Photo #64 View of deteriorated canopy at Stambaugh Building, old band hall.

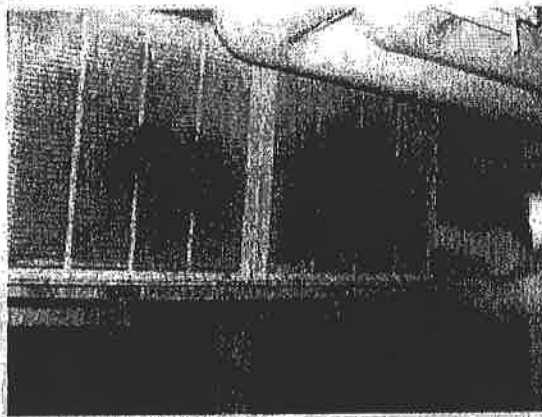
Photo #135 Typical corroded return air grilles of AHUs in the Main Building

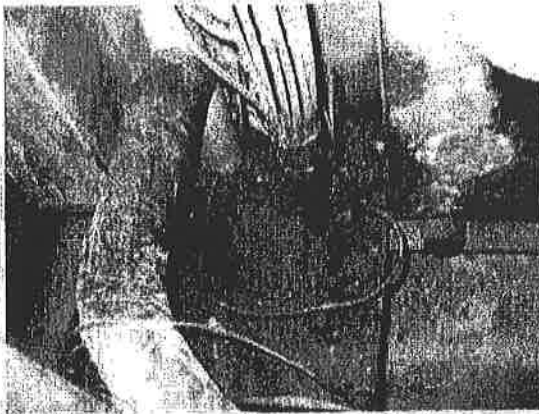
Photo #139 Debris built up in condensate drain pan of AHU in the Main Building

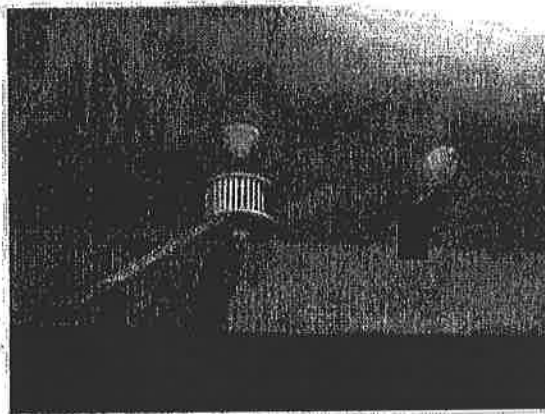
Photo #141 Typical ceiling fan with bent fan blades

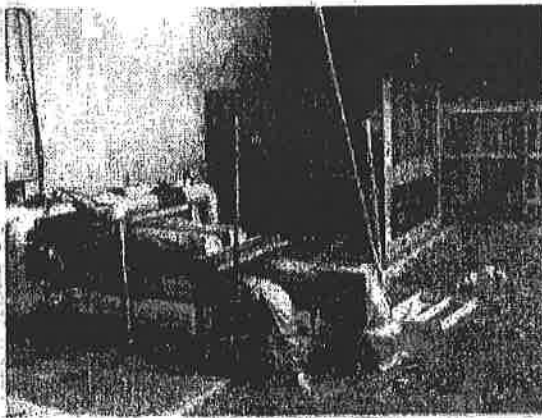
Photo #145 Damaged chilled/hot water piping at the mechanical room of Main Building.

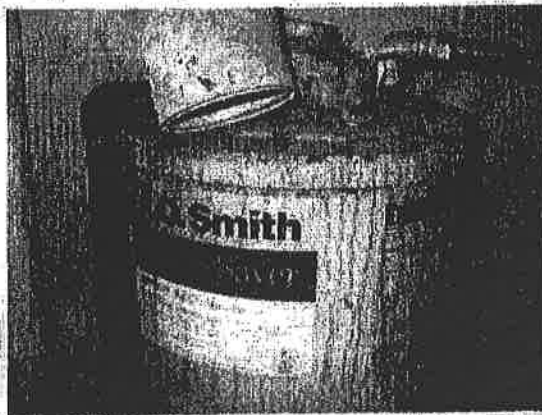
Photo #147 Corroded water heater serving the Cafeteria Building

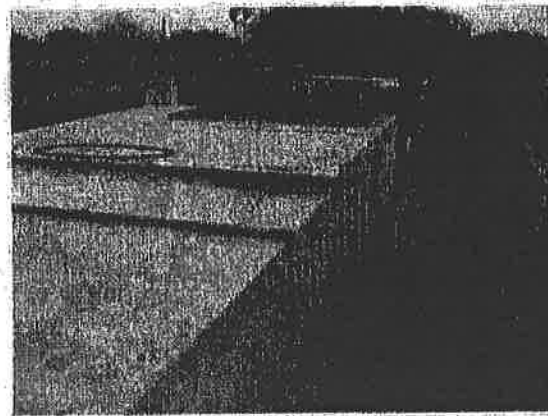
Photo #148 Abandoned RTUs on the Textbook Department Building

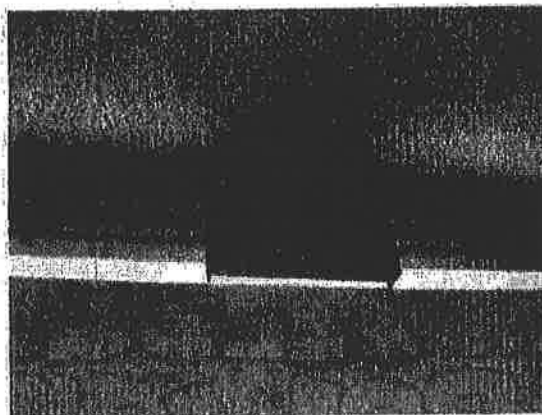
Photo #149 Damaged exit light in the Stambaugh Building

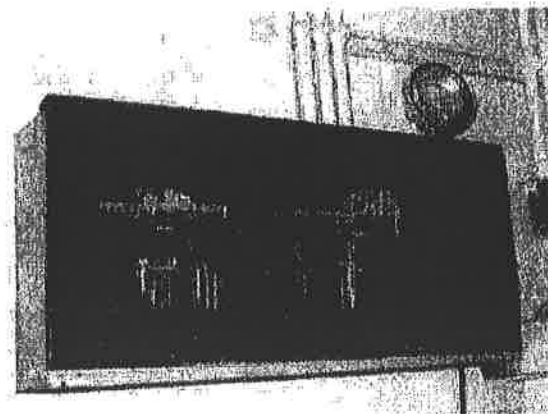
Photo #150 Deteriorated emergency battery pack in the Stambaugh Building

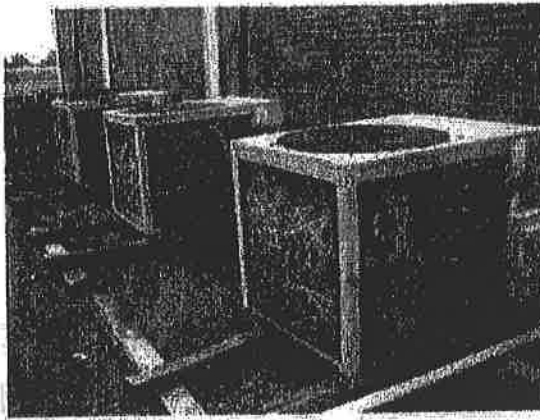
Photo #151 Vandalized condensing units on the
Gymnasium Building
